**TOPIC OF THESIS: ASSESSMENT OF  
CONSTRUCTIONS STRUCTURES PROBLEMS IN  
HIGH TEMPERATURE IN NIGER**

**MASTER'S THESIS**

**Civil Engineering Department**

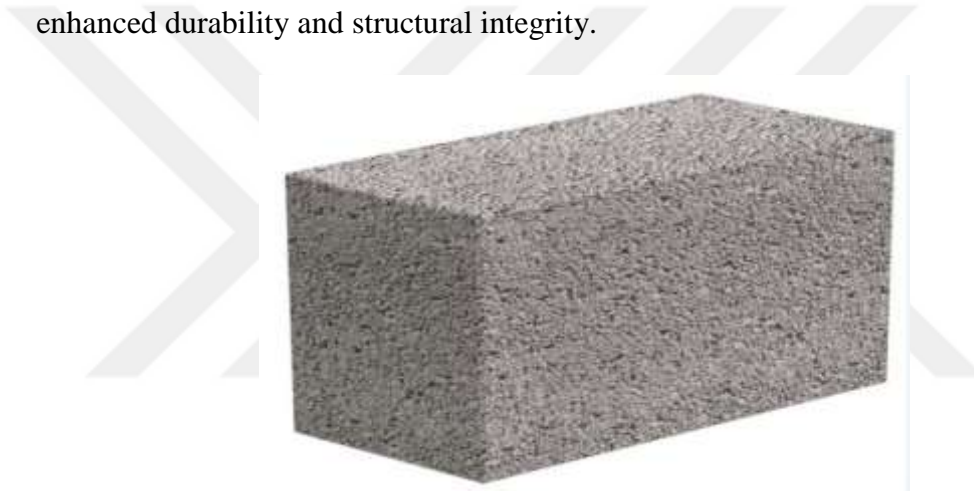
Figure 3.2: Concrete Wall (Cast Dense)

We decide to use a cast dense concrete wall for Scenario 1, ensuring enhanced durability and structural integrity.

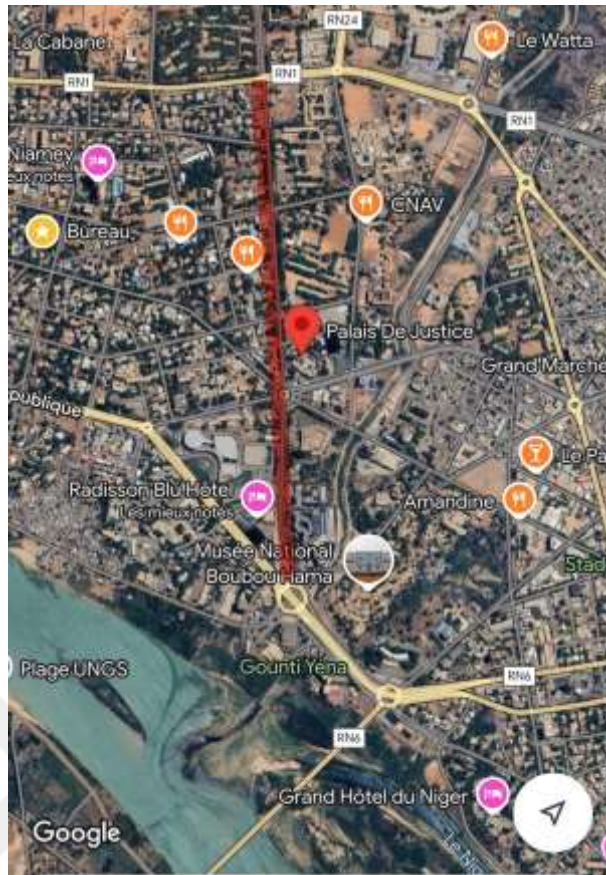
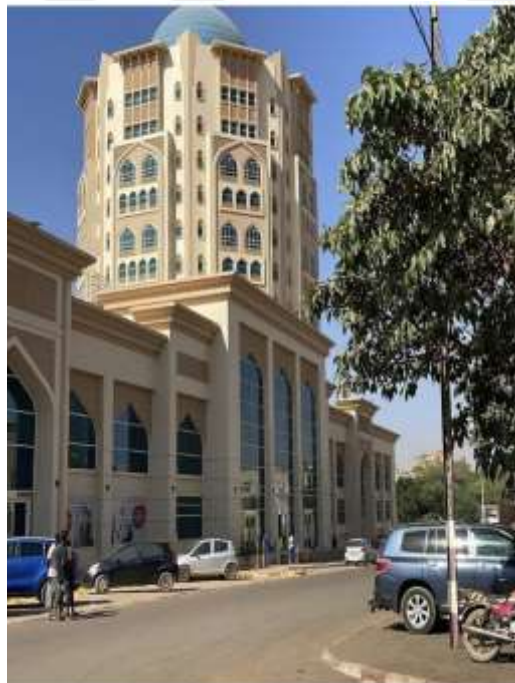
- The Street was built with a length of 950 m and a width of 24 m. It contains pedestrian
- Paths with a width of 5.5 m on both sides. The street does not provide any thermal comfort
- Requirements for pedestrians, such as shading and vegetation.
- Which are shown in figures (6) and (7).

**Figure 3.6: Kalt Casten Street ( Google Maps)**

**Figure 3.7: Klat Casten Street (Pedestrian)**

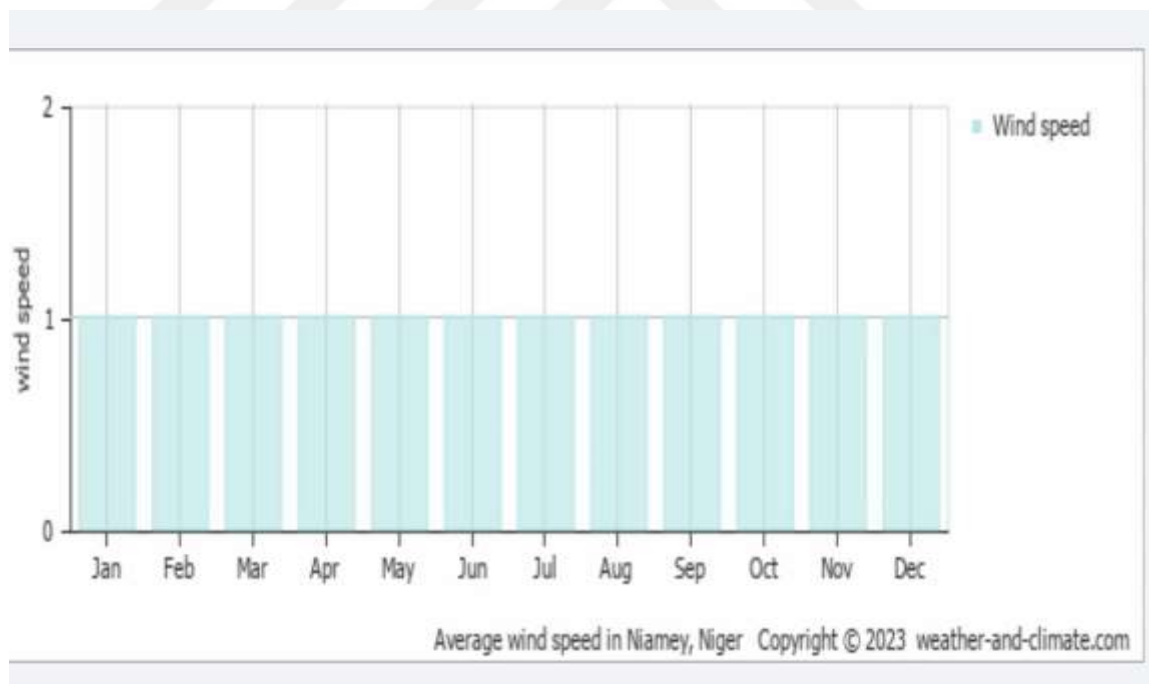
**Figure 3.8: wind speed**

Niamey is experiencing partly cloudy conditions with a temperature of 66°F (19°C). Winds are blowing from the northeast at speeds ranging from 6.7 to 11.2 mph (10.8 to 18 km/h), with gusts up to 15.6 mph (25 km/h).

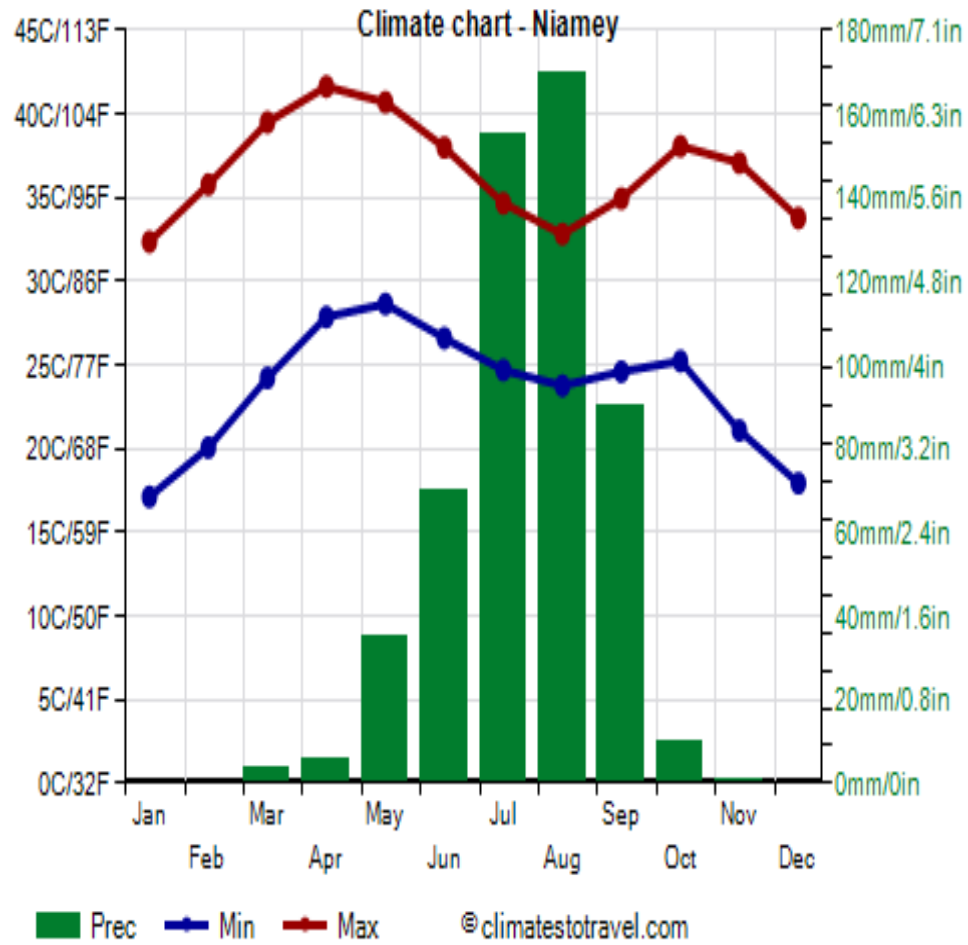
**Figure 3.10: Temperature**

In terms of temperature experiences, it is some of the highest one in the world, with temperature frequently exceeding 40°C during the hot season. Understanding how structures perform and degrade in such extreme conditions is crucial for ensuring their durability and safety.

Often exceeding 45°C, which exacerbates the problems associated with high-temperature environments (World Bank, 2020).

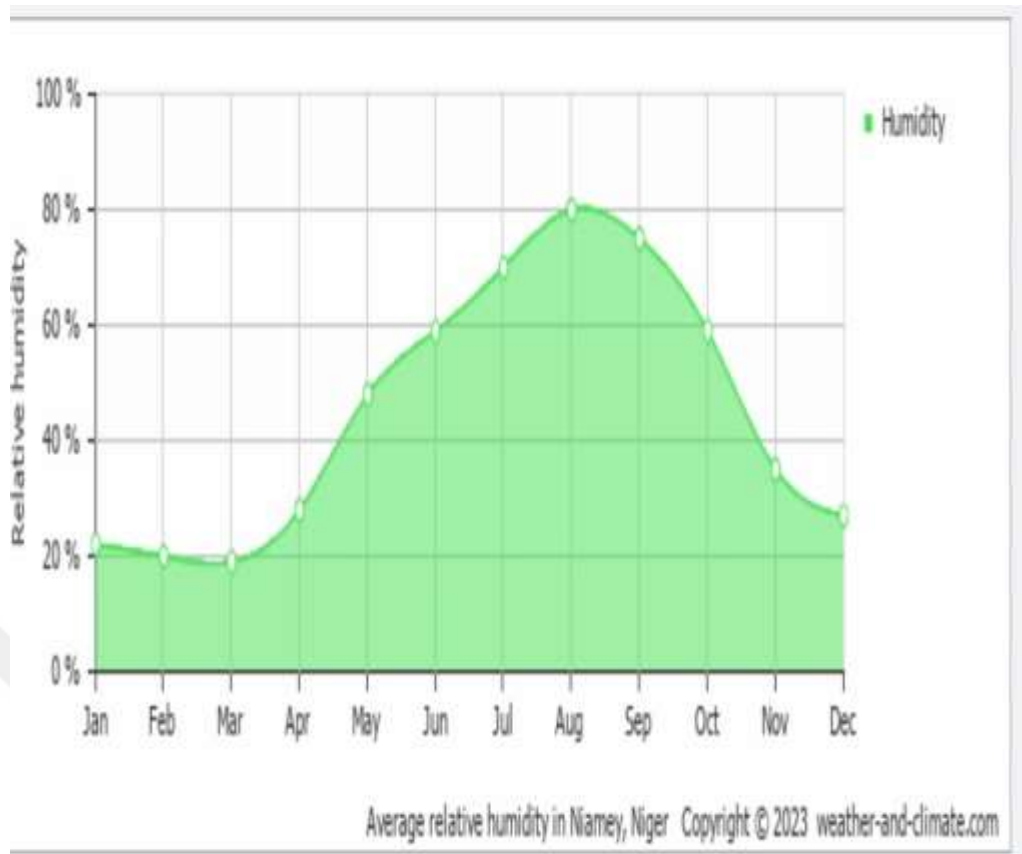
**Figure 3.11: Average Humidity in Niamey**

The average annual relative humidity is approximately 49,5 %, with notable monthly variations. March typically experiences the lowest humidity at around 19%, while August sees the highest, averaging 80%.

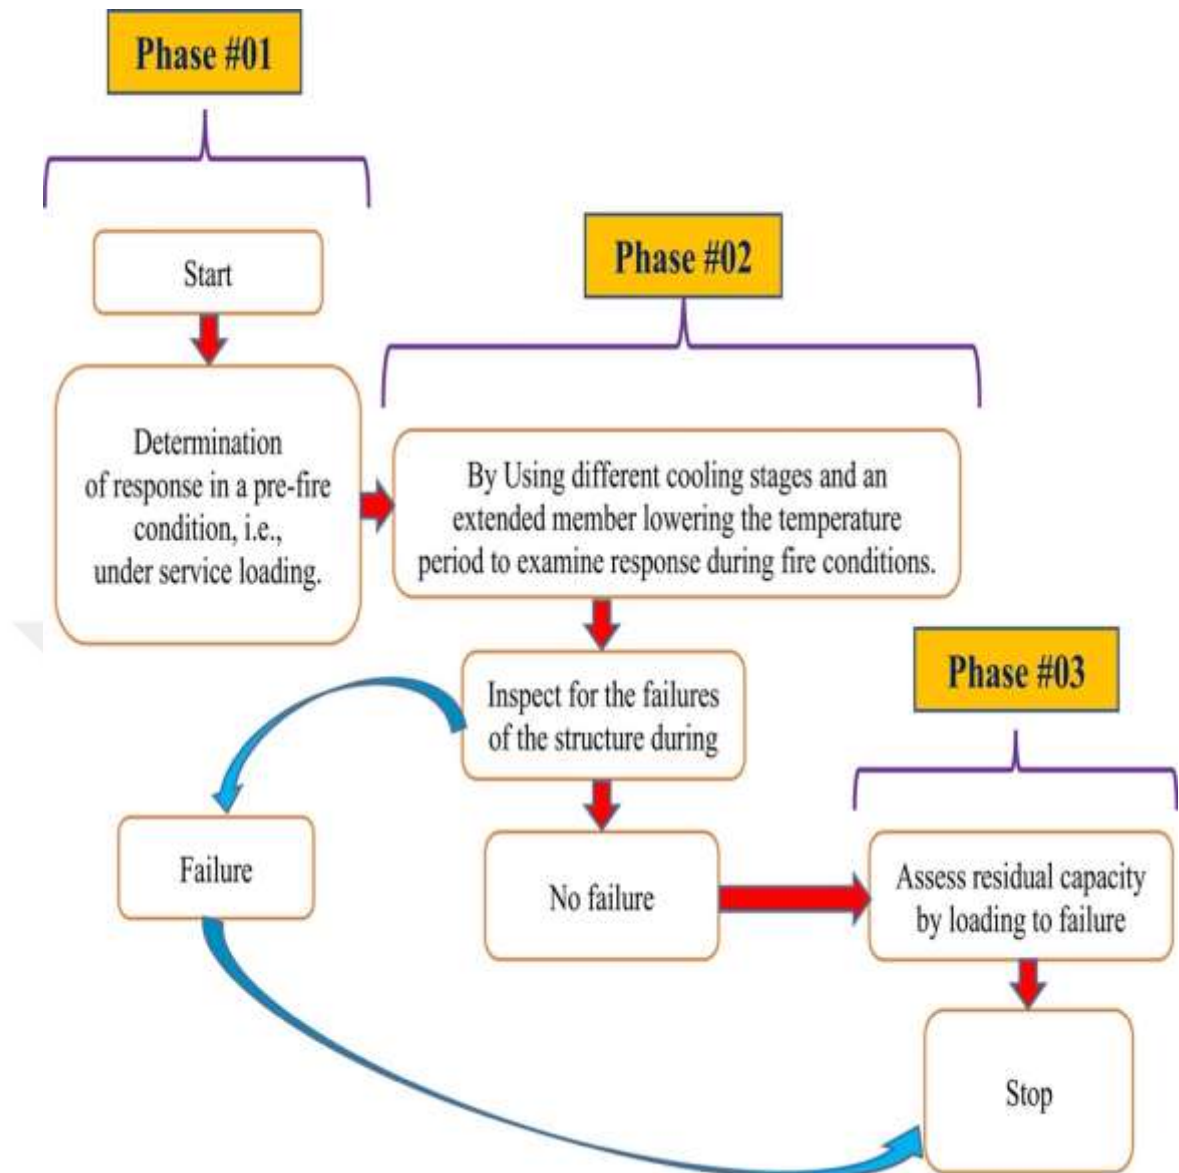
**Figure 4.1: Assessment for Residual Capacity of RC Structural Elements**

Reinforced concrete (RC) buildings possess significant inherent fire resistance, meaning high temperatures do not necessarily lead to destruction. However, a thorough post-fire evaluation is essential due to the variable condition of the concrete. Concrete in buildings exposed to fire often exhibits non-uniform characteristics across its cross-section, with the surface layer typically suffering the most severe deterioration. Despite these challenges, RC structures typically maintain stability after a fire, albeit requiring repairs to address residual damage and deformations.

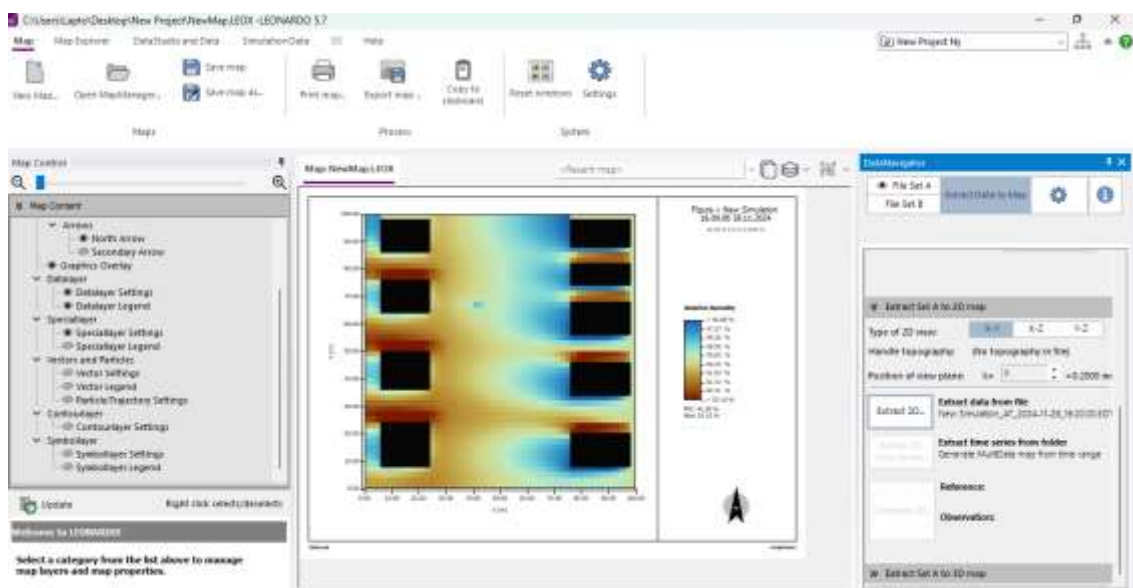
**Figure 4.5: Humidity Simulated By Envi Met**

Humidity plays a crucial role in meteorological events like thunderstorms and storms. At 100% humidity, the air becomes fully saturated with water vapor, leading to the formation of dew or precipitation. Analysis of the relative humidity map from the model used that day shows a maximum value of 54.33 % and a minimum of 46.38 %.

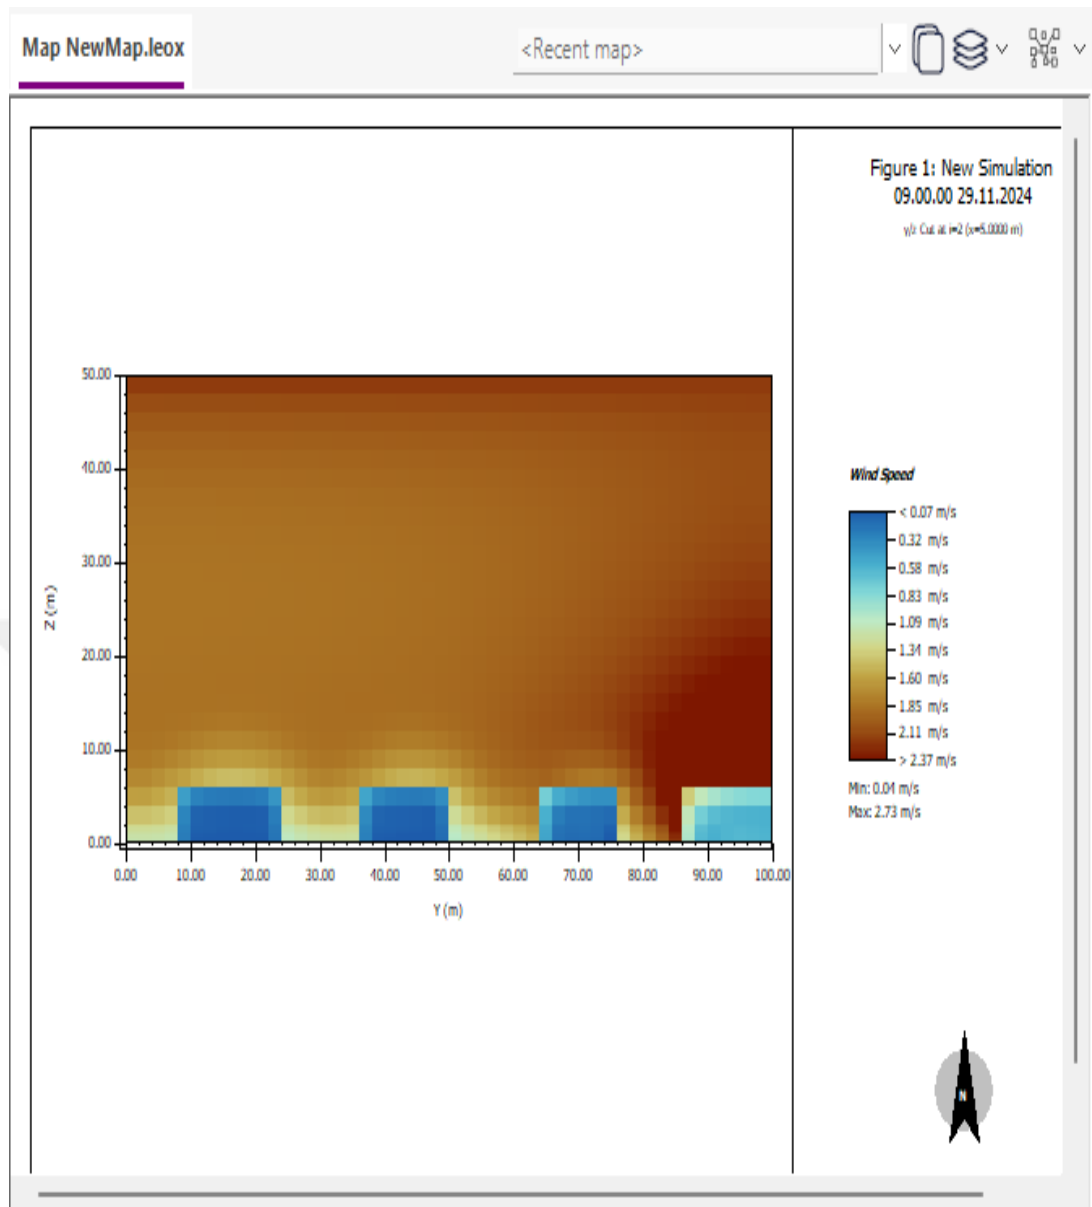
**Figure 4.13: Wind Velocity Simulated By Envi Met Before**

After completing the simulation for the study region and analyzing the wind speed data, which significantly influences the climate, the researcher concludes that the maximum wind speed recorded on that day was 2.73 m/s, while the minimum was 0.04 m/s. This limitation adversely affects thermal comfort.

Before modification	After modification
1	Maximum potential air temperature = 28.76 °C Minimum potential air temperature = 25.83 °C	Maximum potential air temperature = 20.22 °C Minimum potential air temperature = 19.29°C
2	Maximum relative humidity = 62.93% Minimum relative humidity = 52.94 %	Maximum relative humidity = 56.45 % Minimum relative humidity = 39.55%
3	Maximum wind velocity = 2.73 m\s Minimum wind velocity = 0.04 m\s	Maximum wind velocity = 2.67 m\s Minimum wind velocity = 0.03 m\s

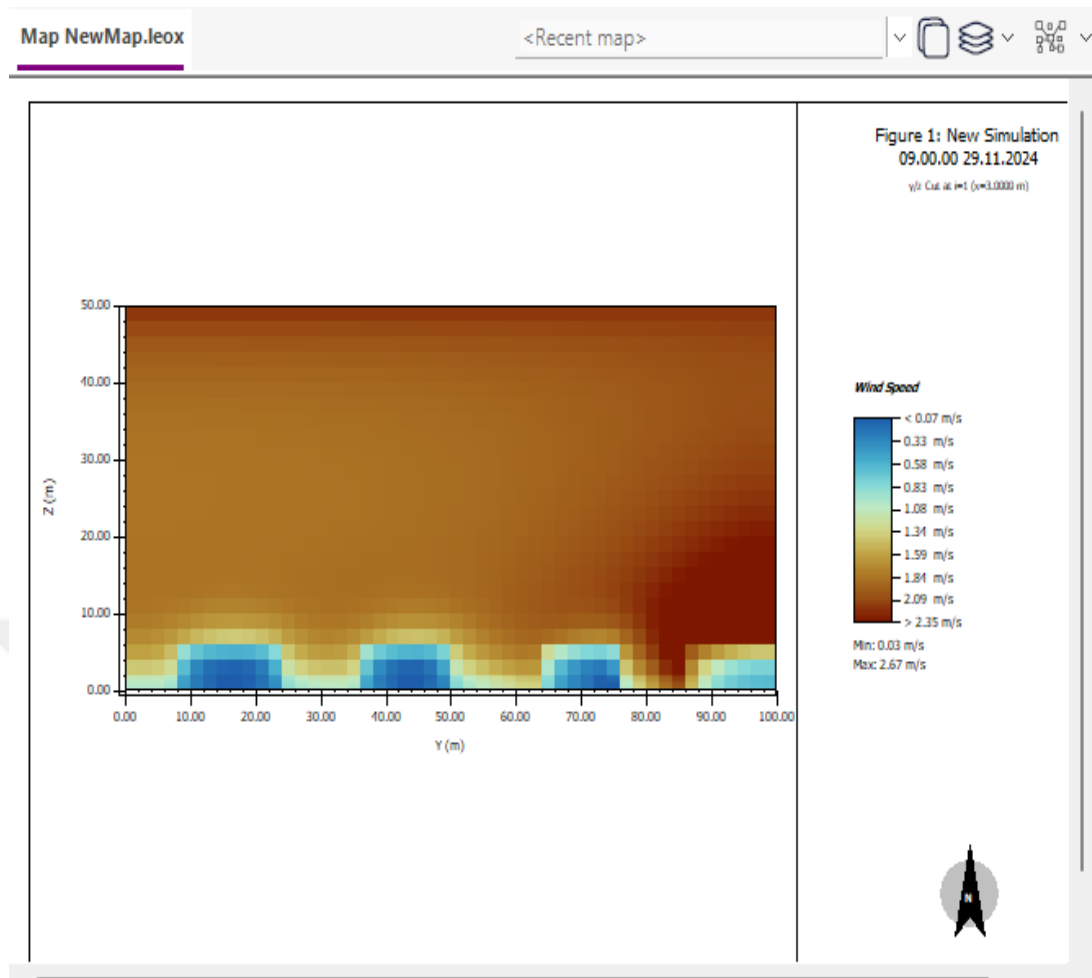
**Figure 4.18: Wind Velocity Simulated By Envi Met**

After modifying the model and simulating it using ENVI-met software, the results showed an improvement in thermal comfort. The maximum recorded wind speed on that day was 2.67 m/s, while the minimum wind speed was 0.03 m/s.
