Keywords: Urban hotels, physically disabled, wheelchair users, accessibility.

An Analysis of the Concept of Accessibility in the Common Areas of Urban Hotels from the Perspective of Wheelchair Users: Three Hotels in Pendik'

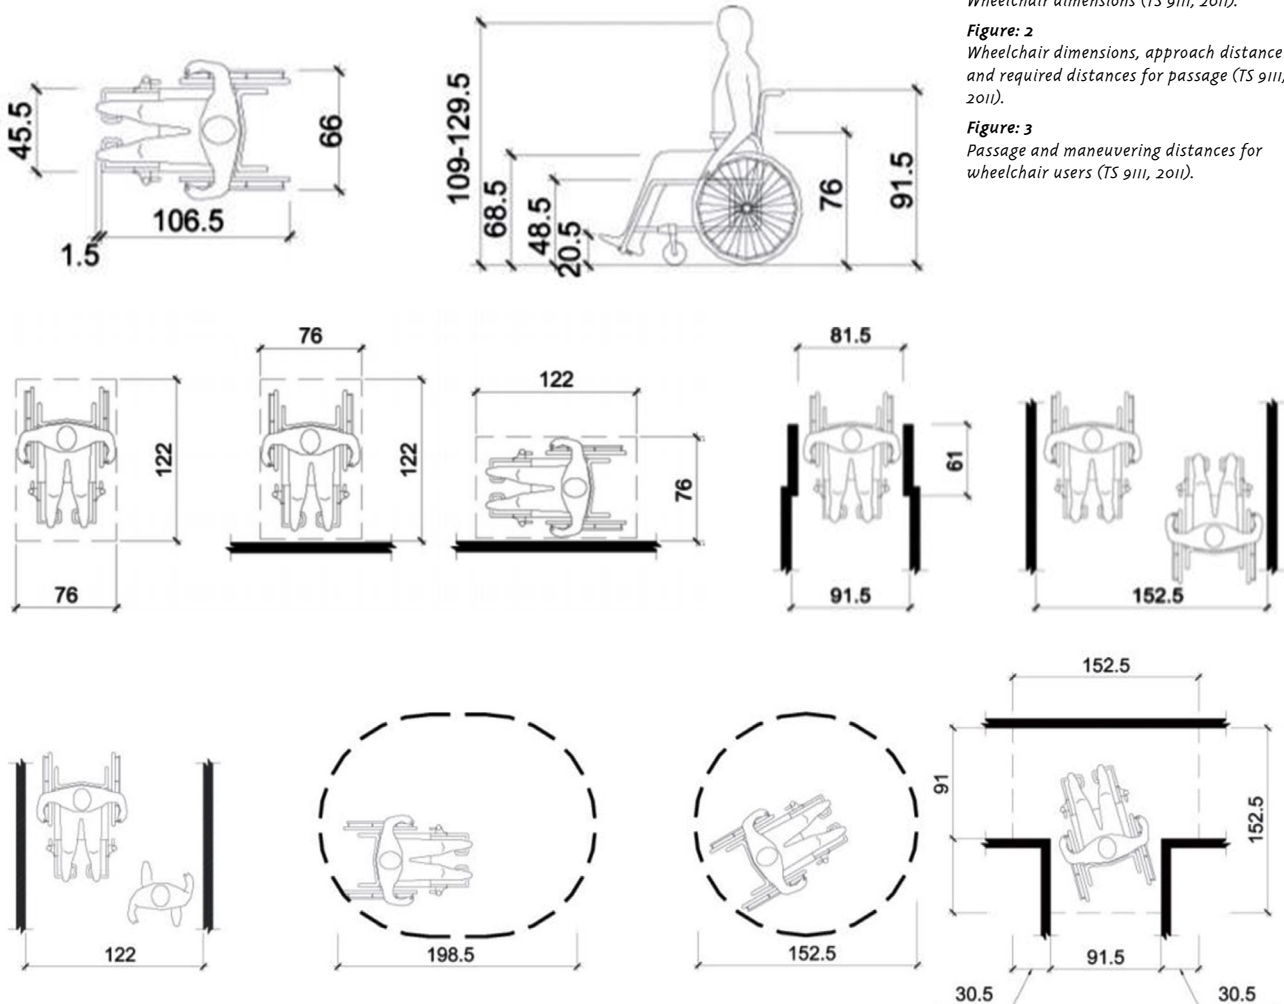
Figure: 1
Wheelchair dimensions (TS 9111, 2011).

Figure: 2
Wheelchair dimensions, approach distance and required distances for passage (TS 9111, 2011).

Figure: 3
Passage and maneuvering distances for wheelchair users (TS 9111, 2011).

most is the physically disabled individuals. Physically disabled individuals need assisting tools and equipment in order to move and walk, and these tools and equipment necessitate some arrangements to be made in the design of space (Yılmaz 2005, 79). The anthropometric dimensions of a wheelchair, which is among the tools and equipment used by physically disabled individuals, is as follows (Figure 1-2-3).

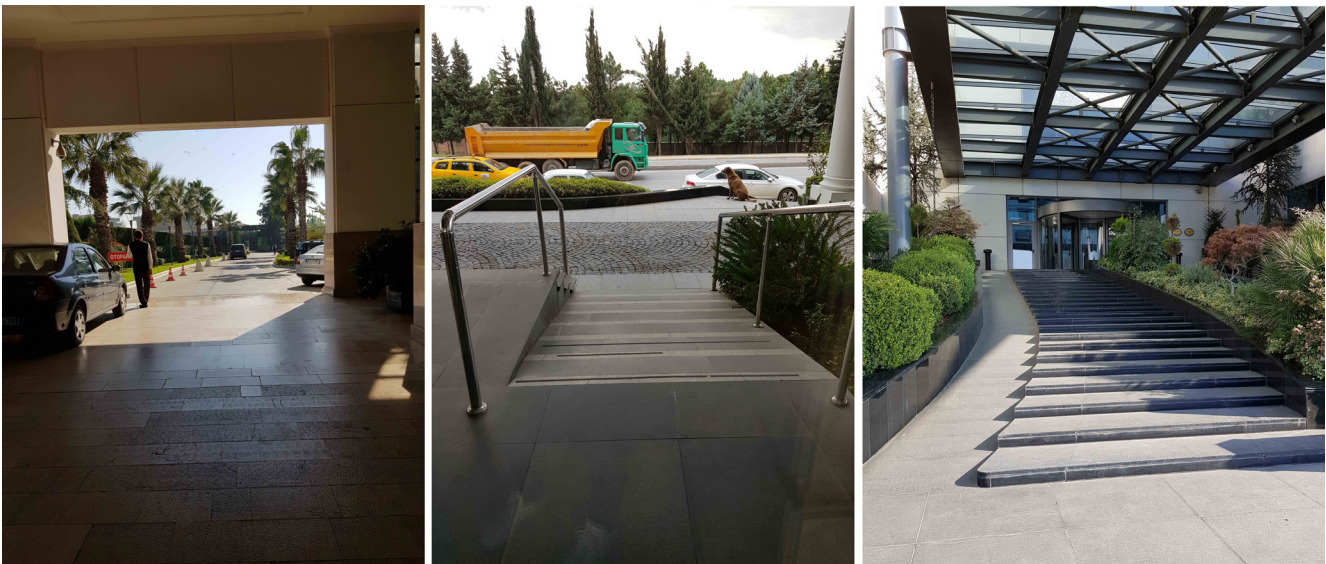
Figure 4
Hotels A, B, and C Building Entrances (Yıldız 2017, 134), (Yıldız 2017, 151), (Yıldız 2017, 168).

Evaluation Areas / Evaluation Criteria		HOTEL A		HOTEL B		HOTEL C	
Access Routes to The Usable Areas of the Building	Recommended	Detected	Suitability Status	Detected	Suitability Status	Detected	Suitability Status
Disability Access and Entrance	Disability access and entrance should be provided in at least one entrance to the building.	Disability access and entrance has been provided in at least one of the entrances to the building.	√	Disability access and entrance has been provided in at least one of the entrances to the building.	√	Disability access and entrance has been provided in at least one of the entrances to the building.	√
All Accessible Route Points	Should be at least 90 cm. wide.	The widths of all accessible route points are above the recommended width.	√	The widths of all accessible route points are above the recommended width.	√	The widths of all accessible route points are above the recommended width.	√

Accessible Route Ramp Slope	It should not be more than 1:12 (%8).	No slope.	√	The slope was applied steeper than recommended.	x	The slope was applied closer to the recommended slope.	√
Existence of Railings on Both Sides of the Ramps	There must be railings on both sides of the ramps that go up higher than 15 cm.	–	√	There are railings on both sides of the ramp.	√	There are no railings on both sides of the ramp.	x
Ramp Railings Height	It must be 90 cm. starting from the surface of the ramp.	–	√	90 cm.	√	–	x
Existence of Ramp Side Guard	There must be side guards of at least 5 cm. high on both sides of the ramp.	–	√	–	x	–	x

- It was seen that accessible route ramp slope in Hotel B was steeper than the recommended level. Since this situation will make it difficult for wheelchair users to use the ramp, the slope should be rearranged in line with the recommended level.

- No railings on both sides of the ramp in Hotel C were considered. As this situation will pose a threat for wheelchair users, railings should be added on both sides of the ramp.
- In Hotel B and C, ramp side guards do not exist. In order to eliminate this danger for the wheel, it is recommended that ramp side guards should be added to the ramps at recommended levels.

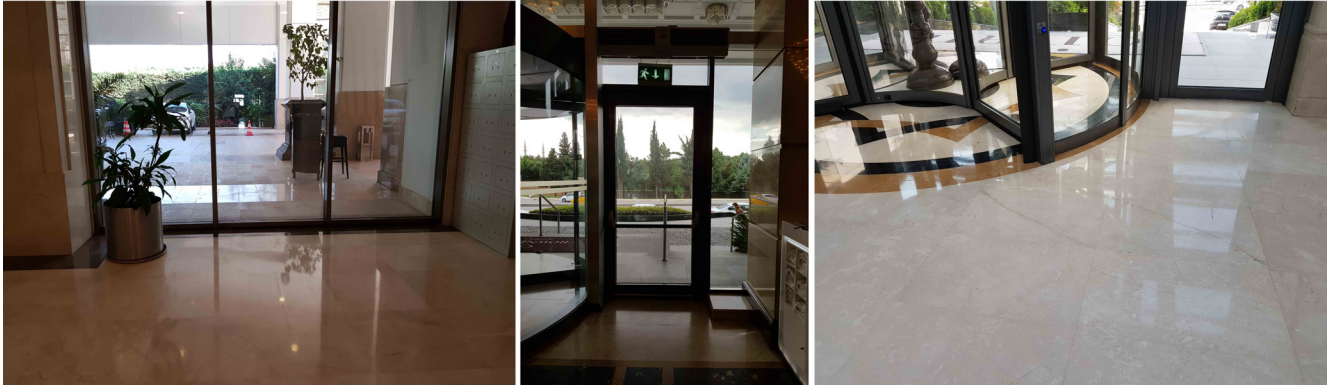
Figure: 5
Hotels A, B and C Entrance Levels (Yıldız 2017, 134), (Yıldız 2017, 154), (Yıldız 2017, 170).

Evaluation Areas / Evaluation Criteria		HOTEL A		HOTEL B		HOTEL C	
Levels at the Entrances	Recommended	Detected	Suitability Status	Detected	Suitability Status	Detected	Suitability Status
Existence of Floor Grates on walking Route	If there are grates on the walking route, the openings in them in one direction must not be over 1.3 cm.	-	√	-	√	-	√
Existence of Ramp etc. Level Difference at the Building Entrance	It must be between 0.6 cm.-1.3 cm.	-	√	-	√	-	√

- In all three hotels, since there is no level difference resulting from grates on the walking routes and ramps at the entrances of the buildings, etc., there is no problem detected in terms of wheelchair use.

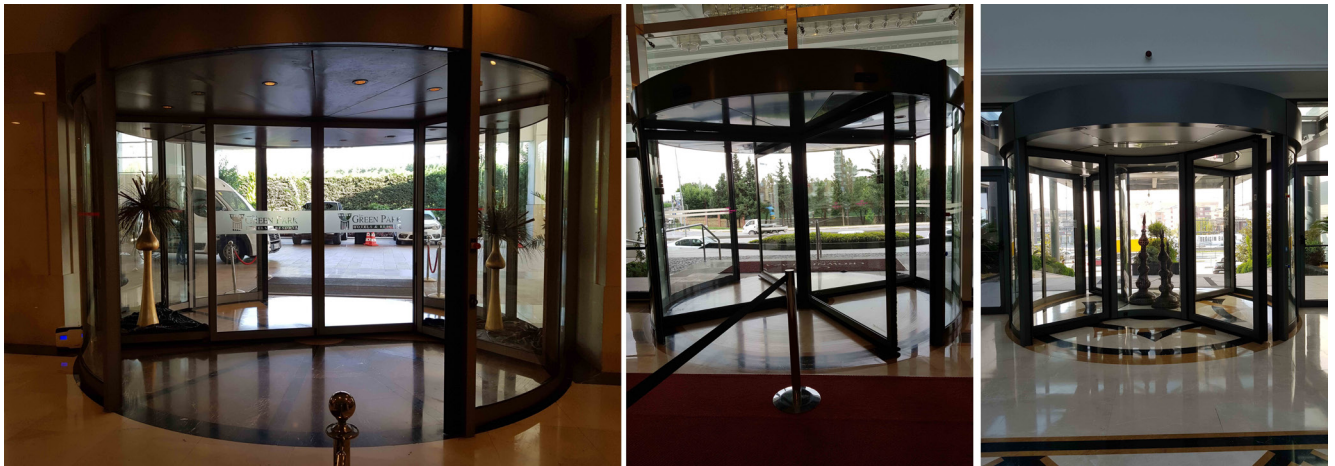
Figure: 6
Hotels A, B and C Entrance Door Width and Layout (Yıldız 2017, 135), (Yıldız 2017, 154), (Yıldız 2017, 171).

Evaluation Areas / Evaluation Criteria		HOTEL A		HOTEL B		HOTEL C	
Entrance Door Width and Layout	Recommended	Detected	Suitability Status	Detected	Suitability Status	Detected	Suitability Status
Entrance Door Type	If there is a revolving door, there must be another door with hinges or photocell.	Revolving door+Photocell door	√	Revolving door+Hinged door	√	Revolving door+Hinged door	√
Entrance Door Width	The width of the main entrance door with two wings must not be less than 150 cm., with one of the wings having at least a width of 100 cm.	Double wings 210 cm.	√	One wing 95.5 cm.	x	One wing 100 cm.	√
The Height of Intercom, Door Bell Panel, and Buttons for the Disabled	It must be between 90 cm.-140 cm.	The height of the button for the disabled is 80 cm.	x	The height of the button for the disabled is 85 cm.	x	The height of the button for the disabled is 88 cm.	x

- The width of the entrance door to Hotel B was found to be narrower than the recommended level. As this situation will create a difficulty for the disabled while entering and exiting the hotel, the door should be

dealt with and made wider.

- In all of the three hotels, intercom and doorbell panel were not available, and the height of the existing buttons did not comply with the recommended level. Intercom and doorbell should be set up at the entrance of the three hotels for the wheelchair users to use in cases when they cannot enter the hotel. Moreover, the existing disability buttons at the doors should be moved to the recommended level.

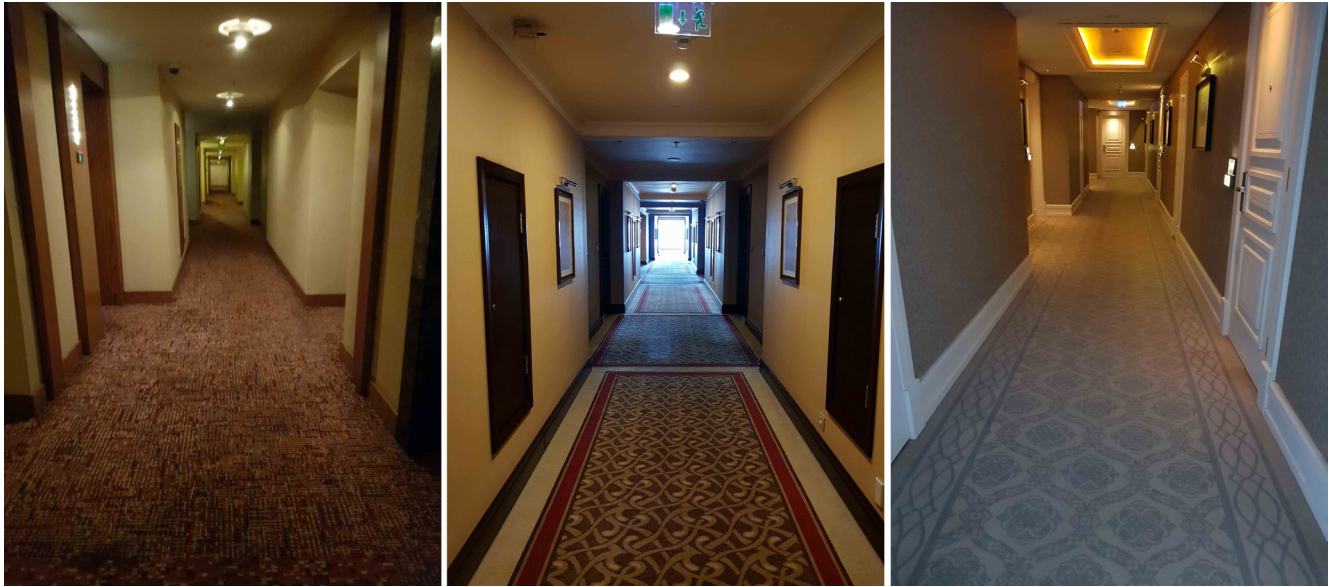
Figure: 7
Hotels A, B and C Corridor Widths (Yıldız 2017, 136), (Yıldız 2017, 155), (Yıldız 2017, 172).

Evaluation Areas / Evaluation Criteria		HOTEL A		HOTEL B		HOTEL C	
The Width of the Corridors	Recommended	Detected	Suitability Status	Detected	Suitability Status	Detected	Suitability Status
Net Width of the Corridors	Disability net width of the corridors must be at least 90 cm.	143 cm.	√	175 cm.	√	163.5 cm.	√
Corridor Corners Being Bevelled	The corners at corridor turns must be designed to be bevelled.	Unbevelled	x	Unbevelled	x	Unbevelled	x
Maneuver Spaces at Corridor Turns	Suitable areas for maneuvering must be created in the corridors.	Suitable area for maneuvering has been created.	√	Suitable area for maneuvering has been created.	√	Suitable area for maneuvering has been created.	√

- In all three hotels, the corners of the corridors were not bevelled. As this situation will constitute a danger during the passage of wheelchair users close to the corners, the corners of the corridors should be rearranged

to be bevelled urgently.

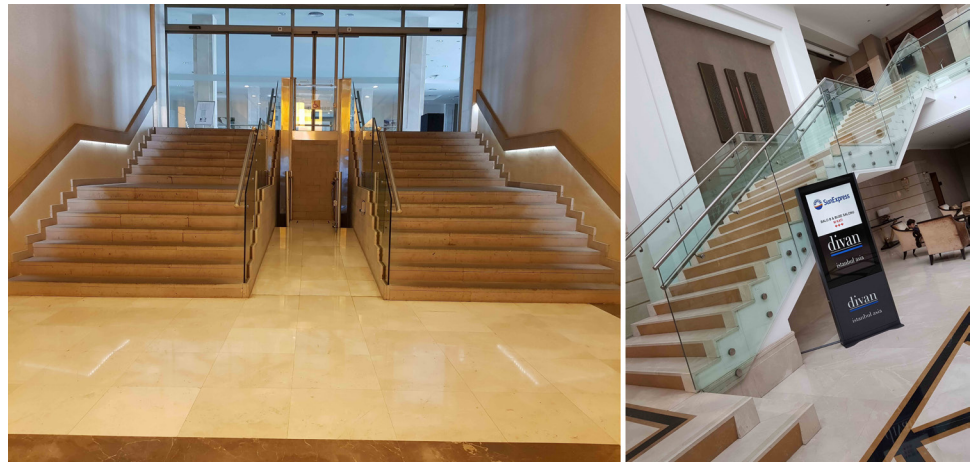
Figure: 8
Hotels A and C Stairs (Yildiz 2017, 137), (Yildiz 2017, 173).

Evaluation Areas / Evaluation Criteria		HOTEL A		HOTEL B		HOTEL C	
Stairs, Platform Raisers	Recommended	Detected	Suitability Status	Detected	Suitability Status	Detected	Suitability Status
Existence of Stairs	–	Existing	–	Not existing	–	Existing	–
Stairs Flight Width	The net width of the stairs must be at least 180 cm. between the two railings.	266 cm.	√	–	–	234 cm.	√
Existence of Platform Raiser	–	Existing	√	Not existing	x	Not existing	x
Width of Access Corridor to Platform Raiser	The disability net width of corridors in the building must be at least 90 cm.	153 cm.	√	–	–	–	–
Height of Platform Raiser Button	For approaching sideways, the height from the ground must be at most 137 cm, and at least 23 cm.	68 cm.	√	–	–	–	–
Base Area of the platform Raiser	The base area of the platform raiser must not be less than 89 cm. x 152.5 cm.	103 cm.x148.5 cm.	Width: √ Height: x	–	–	–	–

- Hotel B and C do not have any platform raisers. In addition to the existing elevators, platform raisers should be considered for wheelchair users to have access to heights that

cannot be accessed with elevator.

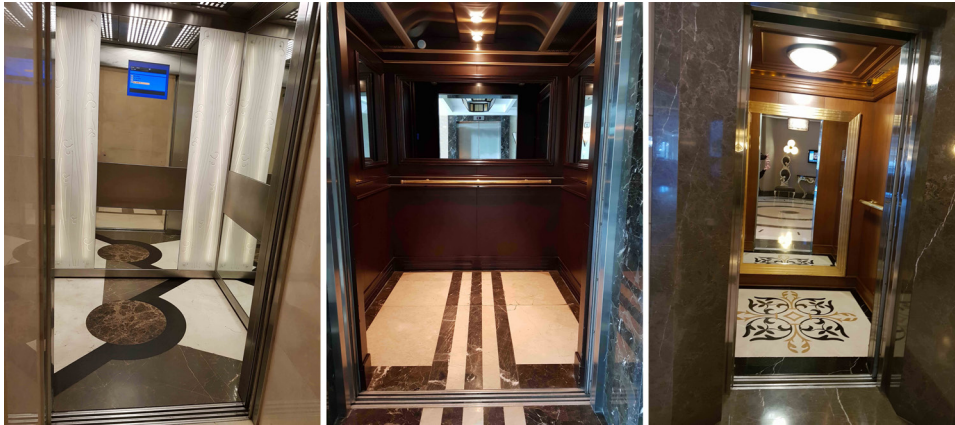
Figure: 9
Hotels A, B and C Elevator Cabins (Yıldız 2017, 138), (Yıldız 2017, 156), (Yıldız 2017, 174).

Evaluation Areas / Evaluation Criteria		HOTEL A		HOTEL B		HOTEL C	
Elevator Dimensions and Control Buttons	Recommended	Detected	Suitability Status	Detected	Suitability Status	Detected	Suitability Status
Cabin Entrance Door Width	Cabin Entrance Door must be at least 91.5 cm. wide.	105 cm.	√	121 cm.	√	90 cm.	x
Width and Depth of the Elevator Cabin	129.5 cm.x172.5 cm.	145 cm.x157 cm.	Width: √ Depth: x	168 cm.x174 cm.	Width: √ Depth: √	141 cm.x151 cm.	Width: √ Depth: x
Existence of Holding Bars	–	–	x	+	√	+	√
Height of Holding Bars	In the cabin, there must be holding bars at a height of 85-90 cm. from the floor.	–	x	105 cm.	x	102 cm.	x
Existence of Emergency Phone	It is recommended that there be an emergency phone in the cabin.	–	x	–	x	–	x
Floor Material of the Elevator Cabin	The floor must not be covered with carpets holding to the floor.	–	√	–	√	–	√
Existence of Seating Opportunity in the Cabin	It is recommended that there be a small folding seat in the cabin.	–	x	–	x	–	x

The height of Elevator Call Buttons	Elevator call buttons must be at a height of 106.5 cm.	110 cm.	x	110 cm.	x	104 cm.	x

- It was determined that the width of the elevator cabin door in Hotel C was not within the dimensions recommended. This problem, which will constitute an obstacle for wheelchair users to enter the cabin, should be solved by changing the elevator cabin with a cabin with a wider door.

- In Hotel A and C, the depth of the existing elevator cabins do not comply with recommended dimensions. Elevator spaces should be designed so as to match these dimensions, and cabins with suitable dimensions should be placed.

- In Hotel A, holding bars in the elevator cabin do not exist. Holding bars should be mounted in the cabin for wheelchair users to get support in a potential situation.

- In Hotel B and C, the heights of the holding bars in the existing elevator cabins do not match the recommended height. Holding bars should be moved the recommended height for wheelchair users to have easy access.

- In all three hotels, seating was not planned in elevator cabins. A seating element should be added to each cabin to provide opportunity for easy transfer from the wheelchair.
- In all three hotels, the heights of elevator call buttons did not comply with the recommended dimension. The height of elevator call buttons in each hotel should be arranged for easy access of wheelchair users.
